## The Restoration on Sūq Ḥarāj

(Antoine Fischfisch  
and Michel Daoud)

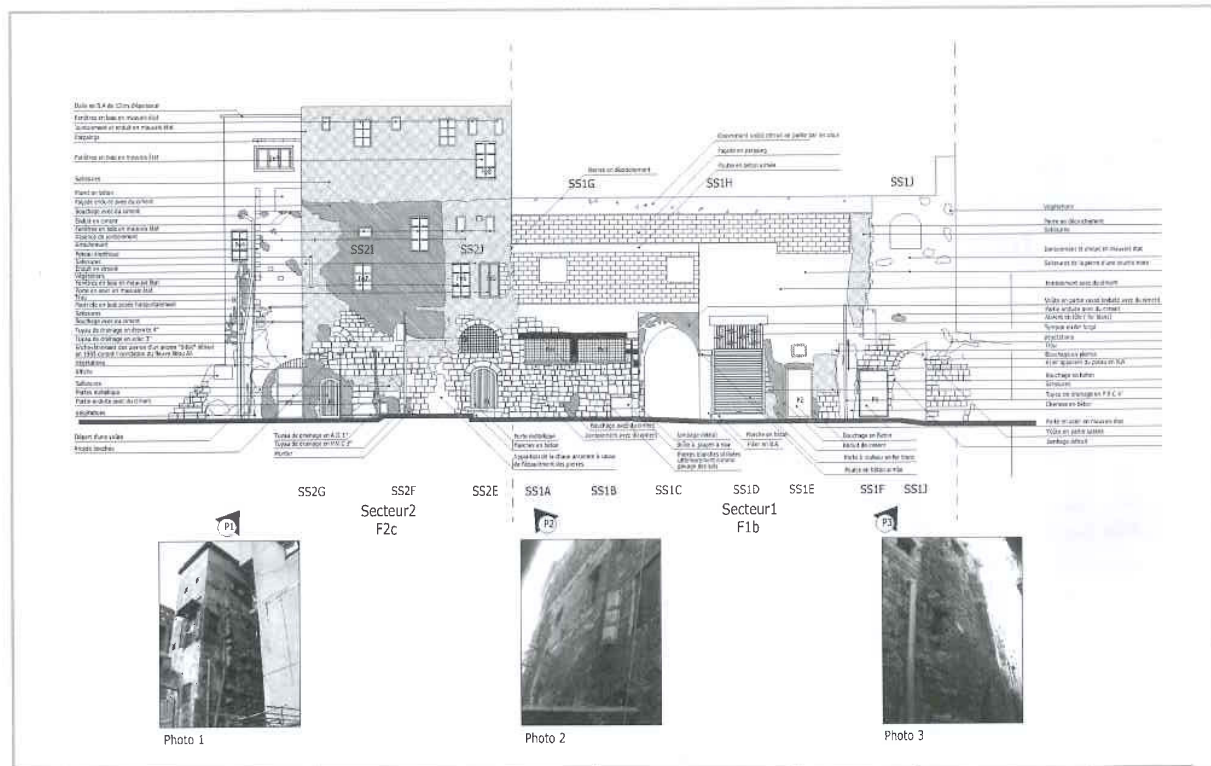
For example, sector 1-a, the southern rectangular block of the eastern side of the *sūq* with one façade to the inner courtyard and another façade towards the Zuqāq al-Sūsiyye: In the war years (1975 – 1990) this sector was hit by six grenades and most severely damaged. The outer façade (F1b) was destroyed in large parts, as were the vaulted galleries on the first floor, the roof, the ceiling and several shops on the ground-floor (Fig. 8).

Fig. 8- Eastern street elevation before restoration (Fischfish/Daoud 2003).

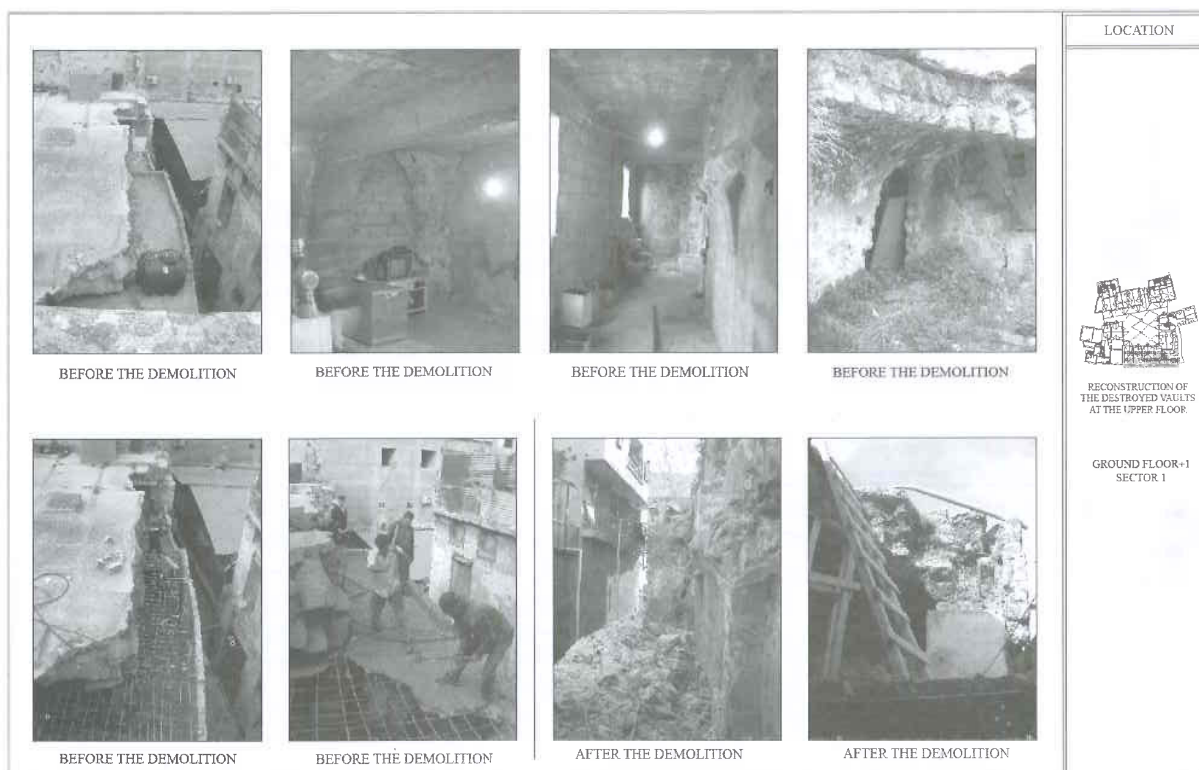
Fig. 9- Deconstruction of modern alterations eastside (Fischfisch/Daoud 2003-04).

Cleaning the site from all kinds of debris; removal of weeds by tearing the creepers off the façades – manually, without applying any chemical product and, above all, without harming the historical stonework. Cleaning the structure from unsuitable materials means:

- Removing pieces of metal or fragments of wood fastened to the inner or outer walls – cautiously, not tearing them off so that the neighbouring stones will not be damaged.

- Removing the provisional doors and windows as well as all materials marked in the graphic documentation as blocking up the openings and skylights.

- Exposing the ceilings and other concrete structures, using manual tools in those places that are very near to ancient structures.

Before any exposure, scaffolds and props were erected for the safety of the workers (**Fig. 9**).

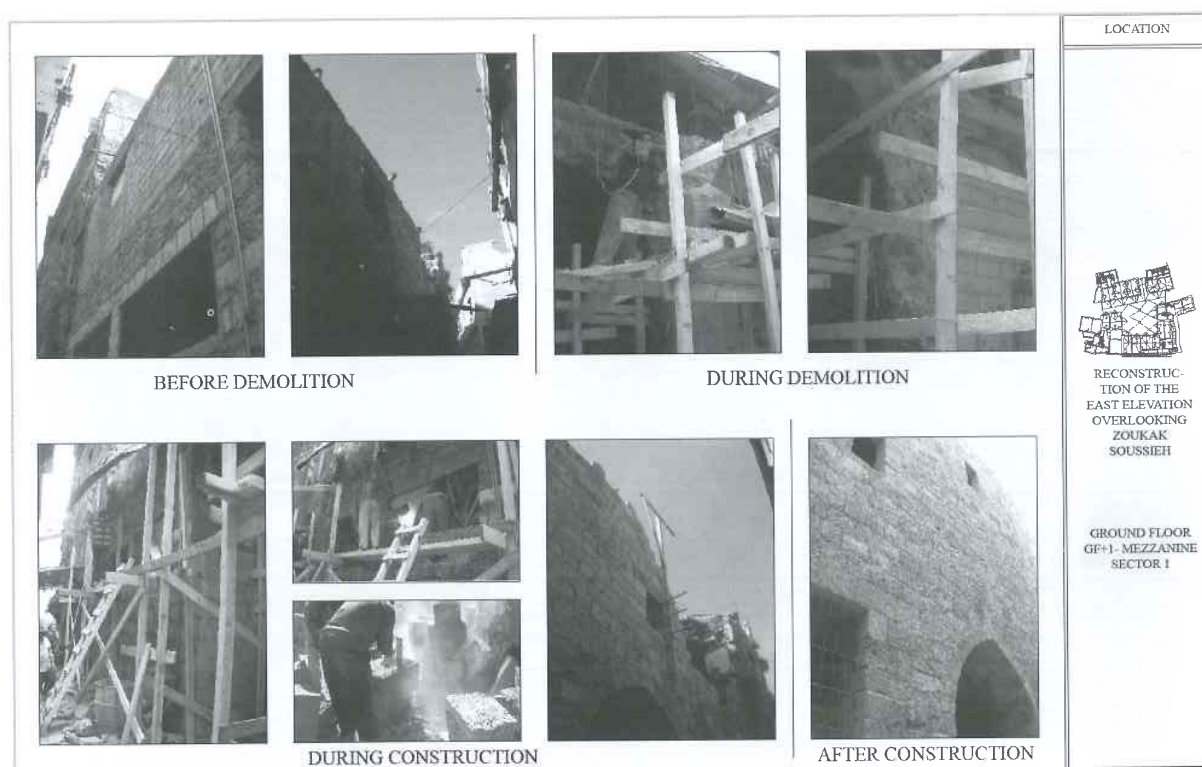
Fig. 10- Reconstruction of eastern elevation and living units first floor (Fischfisch/Daoud 2003-04).

Preparing the foundation of sub-sectors (SS1A) and (SS1B) by laying open the original foundation and consolidating the destroyed parts with the help of a concrete anchorage. In that region a nylon cover

was spread to separate the archaeological level from our intervention. For the reconstruction in natural stones an adequate stone had to be chosen and put in place according to the traditional method. In order to differentiate the new building-measure from the original one we have provided leaden dating marks (size 5x15x80 mm) all around the reconstructed surface and in every vertical joint between a reconstructed layer of stones and an old layer. Lengthwise the marks have been put perpendicularly to the frontal surface and pushed in deep between the stones so that their narrow side is at the same level with the mortar of the joints (**Fig. 10**).

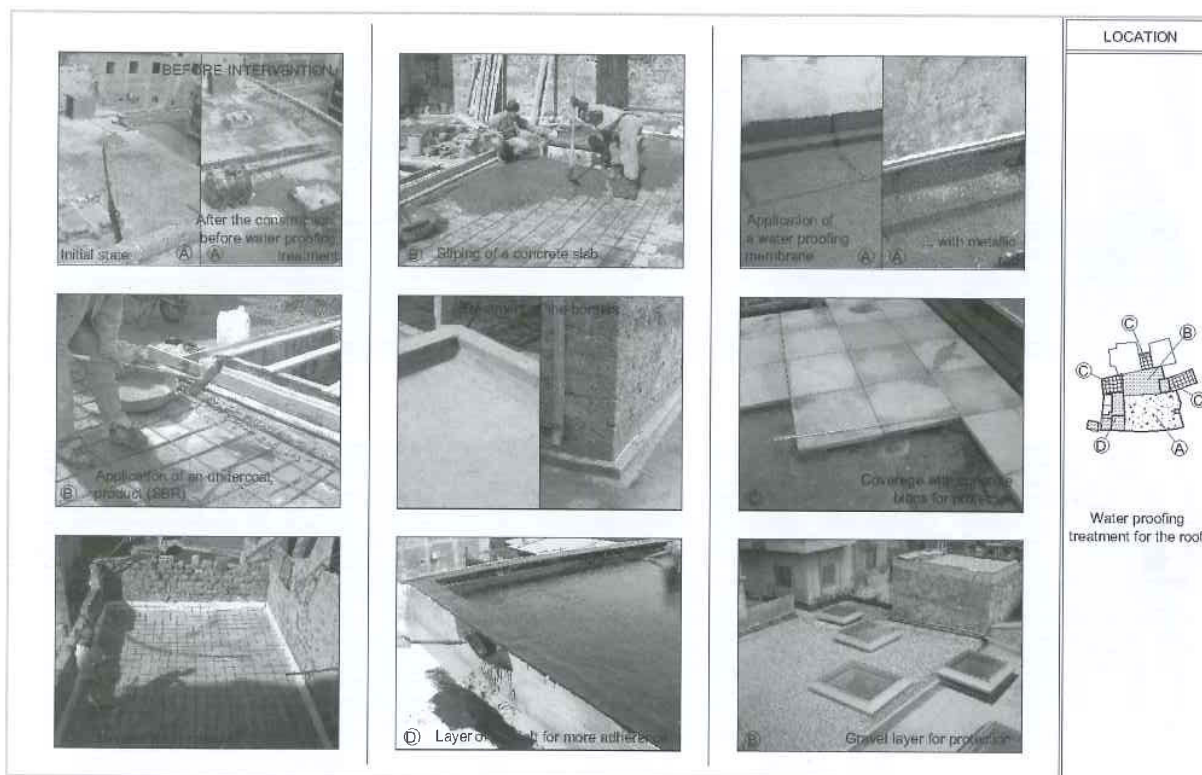
Fig. 11- Treatment of the roofs and roof terraces (Fischfisch/Daoud 2003-04).

The roofs has been protected by means of a waterproof cover of high quality and considerable longevity. A layer assuring adhesion of the two concrete beds has been spread; above it has been applied a multi-layered membrane (SBS, 4.5 kg/m<sup>2</sup>) of hot bitumen in connection with a heavy glass cloth and a polyester film protective against piercing and against weeds taking root. Finally the following layers have been put on top:

- A separating Geotextile layer (d=2) over the complete surface covered by the membrane.
- Thermal insulation of the terrace by means of 5 cm of gravel.
- With the same end in view, concrete slabs have been put on concrete blocks in order to facilitate

access to and utilization of the terraces in front of the apartments and also to facilitate maintenance work. The top of the parapets has been protected by a galvanized metal sheet in the manner described in the plans (**Fig. 11**).

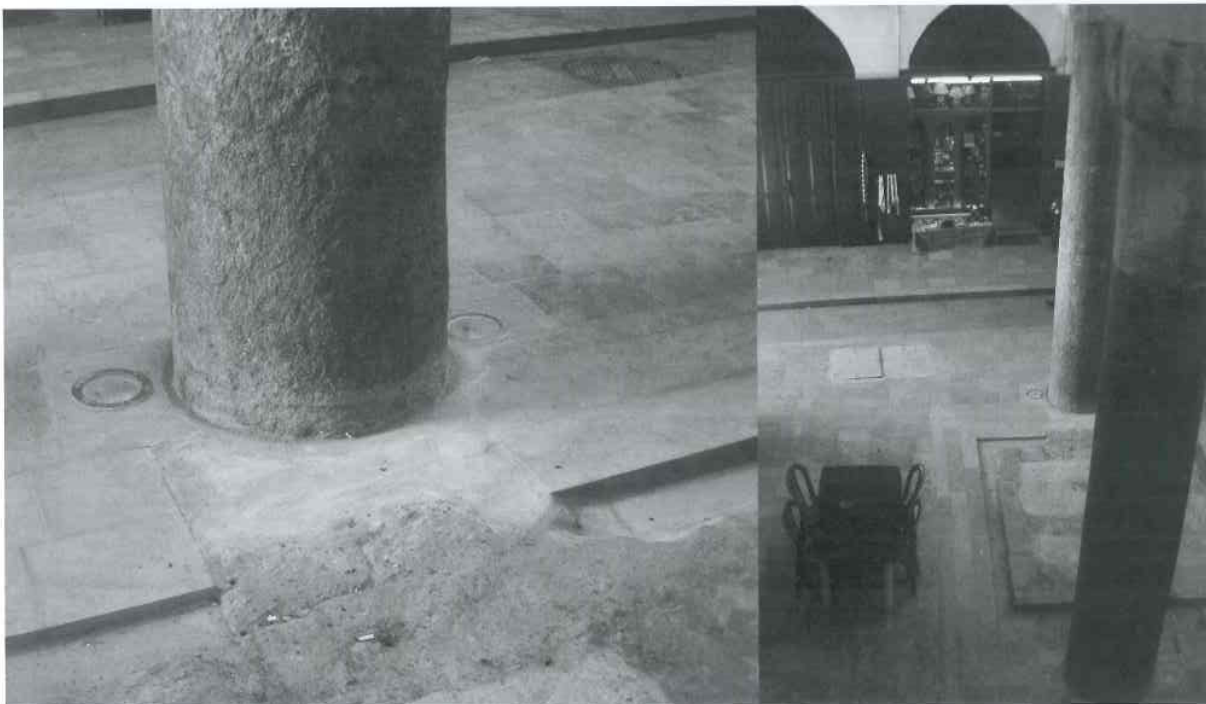
Fig. 12- Pavement hall (Fischfisch/Daoud 2005).

The operation of removing the old pavement and laying the new one included:

- Removing the concrete layer without damaging the underlying pavement. The measure was supervised by an archaeologist from the DGA (Direction Générale des Antiquités) and the DAI (German Archaeological Institute).

- After a thorough cleaning of the complete pavement the slabs in situ were given numbers, they were photographed and manually deposited without breaking them.

- Above an insulating Geotextile a layer of coarse gravel (5 to 10 cm) was raised to a little dam in order to prevent the rising of water through capillaries in the humid soil.

- Another layer of 2 to 4 cm of fine gravel and more sand was spread to adjust the horizontal level.

- Putting back the old paving-stones by the numbers after they have been brushed with clean water and a plastic brush. A mixed cement mortar was used for the bed.

- Dating marks were put along the edge of the old pavement.

- The paving was completed with new stones 3 cm thick and in dimensions and texture identical with the old ones, as well as similar in colour.

- Lastly the joints were filled again with a mortar composed of natural hydraulic lime and river sand mixed with stone dust in order to come close to the colour of the old pavement (**Fig. 12**).

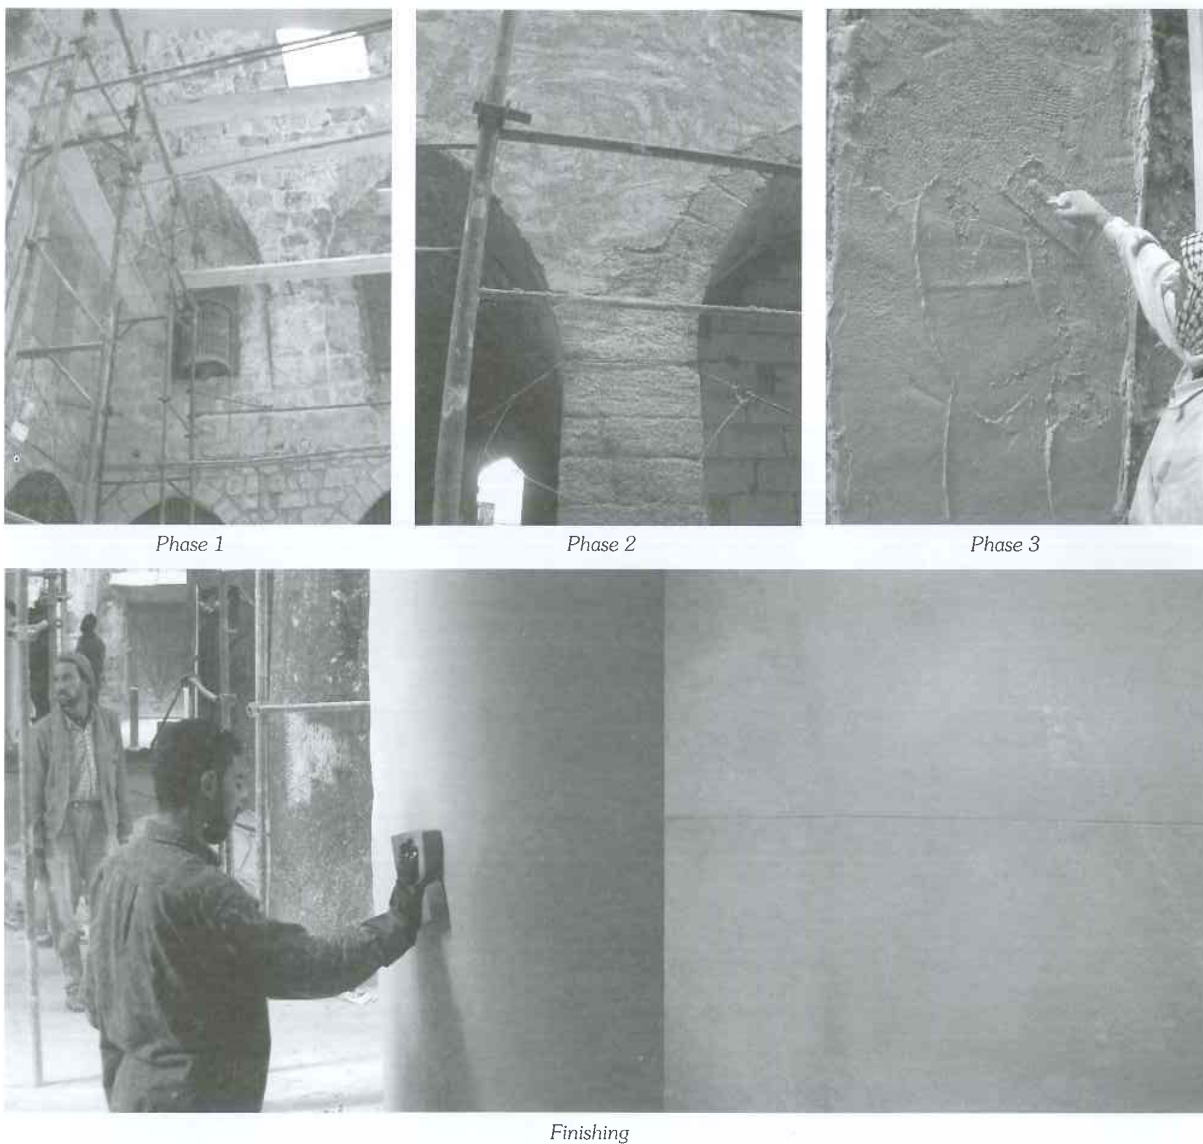
Fig. 13- Application of lime plaster (Fischfisch/Daoud 2005).

It has only been applied to the outer façades of the shop walls and to the east façade as well as to the surfaces of the courtyard vaults. The operation included the removal of the old layer of decayed plaster without damaging the stones, cleaning the supports and the joints between the stones in order to strengthen the adhesion of the lime and the old stone

support, the application of a first layer of plaster at 400 to 450 kg of lime for 1 m<sup>3</sup> of sand, the central layer of plaster had 350 kg/m<sup>3</sup>, the finishing layer had 250 kg/m<sup>3</sup>. On the vaults of the western part of the inner courtyard we found traces of the original plaster in situ and in good condition; we have cleaned the surface and carved a deep joint as a separating mark between the new and the old plaster (**Fig. 13**).

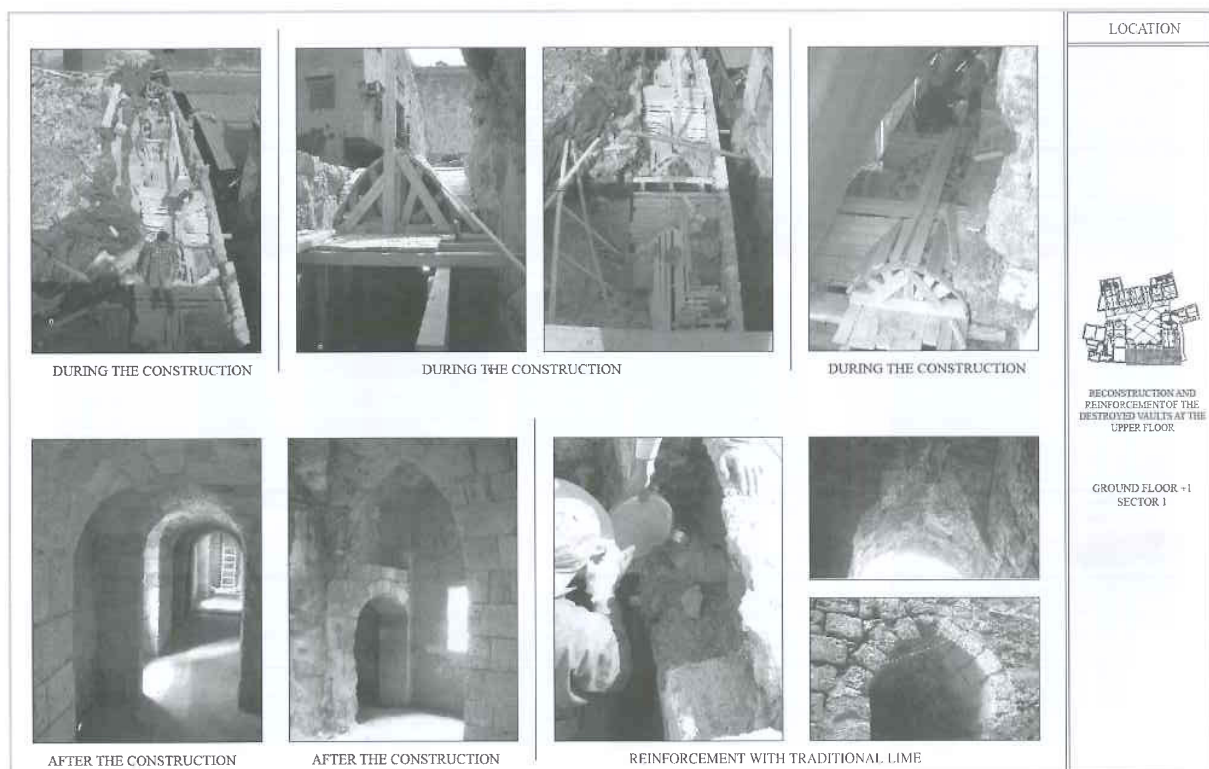
Fig. 14- Reconstruction eastern upper floor and consolidating the stone masonry (Fischfisch/Daoud 2003-04).

The damage caused by the grenades hitting mainly the eastern façade, and by the collapse of the *sibāt* buttressing the northern part of that façade has been remedied by a consolidation which meant filling the blanks and replacing the old mortar – broken by dynamic force or through the decay of its constitutive materials – by means of a new product, a binder injected like a thin mortar. That binder consists of a mixture of white cement and hydrated lime and is very fluid through the addition of a large quantity of water (**Fig. 14**).

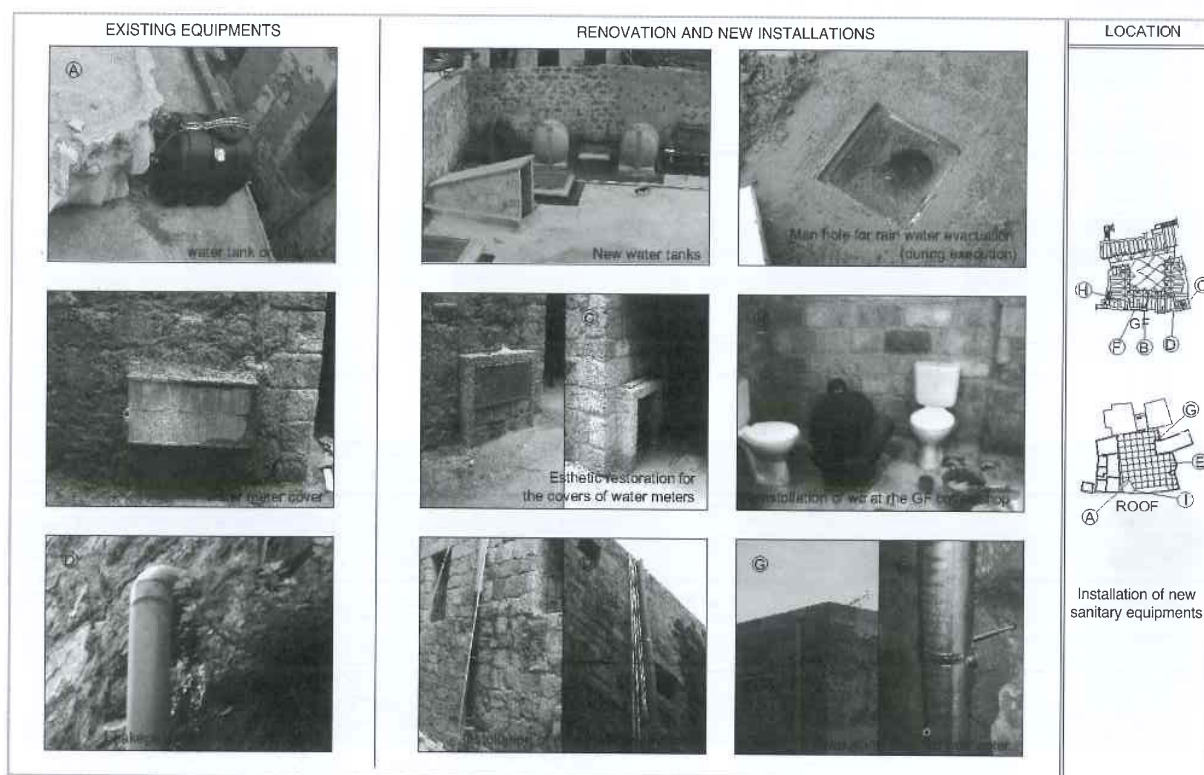
Fig. 15- Sanitary installations (Fischfisch/Daoud 2003-04).

- Water tanks holding 1000 litres for the apartments and the shops of the *sūq*, welded water pipes made of galvanized steel, conforming to the DIN2440 norm, for the distribution of cold water to the households and of drinking water, as described and specified in the plans.

- The pipes laid in the ground were of Polypropylène (PPR) 20-25mm, conforming to the DIN 8077/78 norm.

- For waste water and for rain-water, pipes made of UPVC (ULPI) 4" with accessories of UPVC (READY) have been used. At two metres above ground these pipes have been replaced by cast-iron ones so that they will not be affected by any collision or dynamic force.

- The spy-holes in the ground (60x60 cm) were done in concrete with a cover in reinforced concrete, 6 cm thick.

- The connections to the terrace have been executed by means of pipes made of PVC or of galvanized steel, 2-3" thick. They dispose of rain-water from the higher terraces towards the lower ones or towards the drainage grid, also of PVC.

- The spy-holes / grids made of resistant PVC are 30x30 cm large. They are installed at the outlet of the pipes as indicated on the plans (**Fig. 15**).

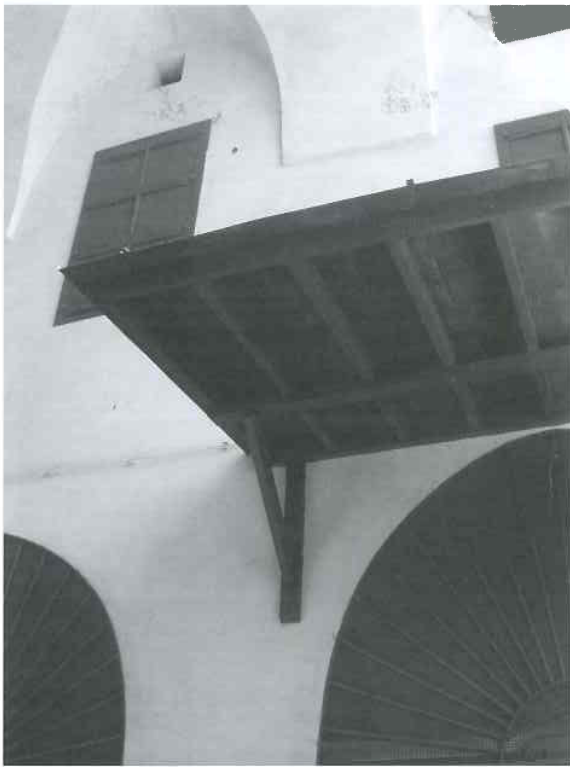
Fig. 16- Example of a canopy (Fischfisch/Daoud 2005).

The new canopies in front of the western row of shops are simplified in shape and material; they are executed as a slight structure of wood and zinc inspired by historical models and those of similar technical attaching without copying a certain historical period in every detail. Four canopies have been financed by the restoring architects, the CDR is going to finance the remaining four (**Fig. 16**).

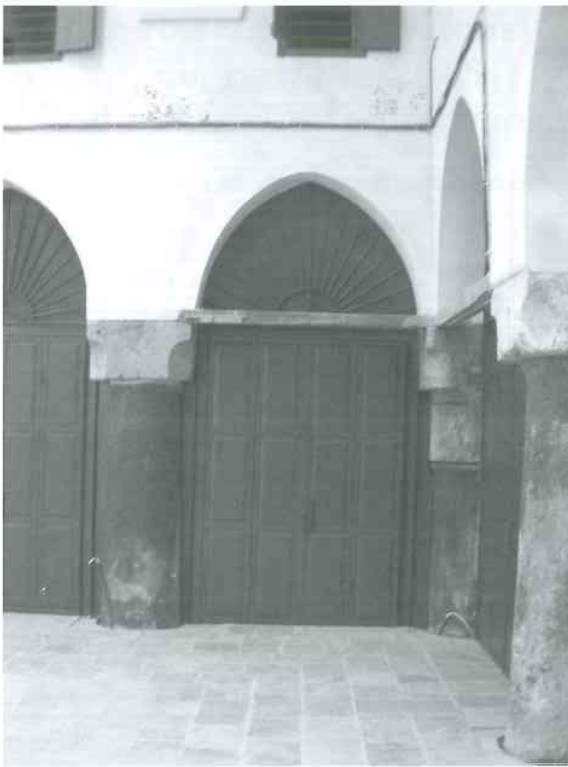
Fig. 17c- New shop shutters with old door lintels as a witness to the Mandate period (Fischfisch/Daoud 2005).

For the sake of security the inhabitants of the *sūq* have replaced their old wooden doors/shop frontage shutters with new metallic ones; only few wooden shop shutters go back to the times of the French Mandate (around 1930). In meeting the needs of the *sūq*'s inhabitants we have chosen a modern interpretation for the shop shutters, in harmony with the historical space but without obliterating the aspect and character of the building's architecture: we have installed shop shutters from metal covered on either side with panels of treated wood but with modern frames so that it is obvious that they are not the original shop shutters. In the north-eastern corner of the courtyard we have left in place two of the shutter lintels as a witness to the Mandate period (**Fig. 17: a-b-c-d**).

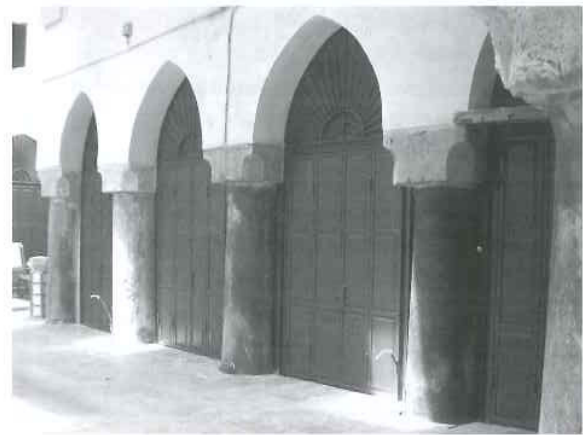
Fig 17d- New shop shutters with metal frames and panels of treated wood (Fischfisch/Daoud 2005).

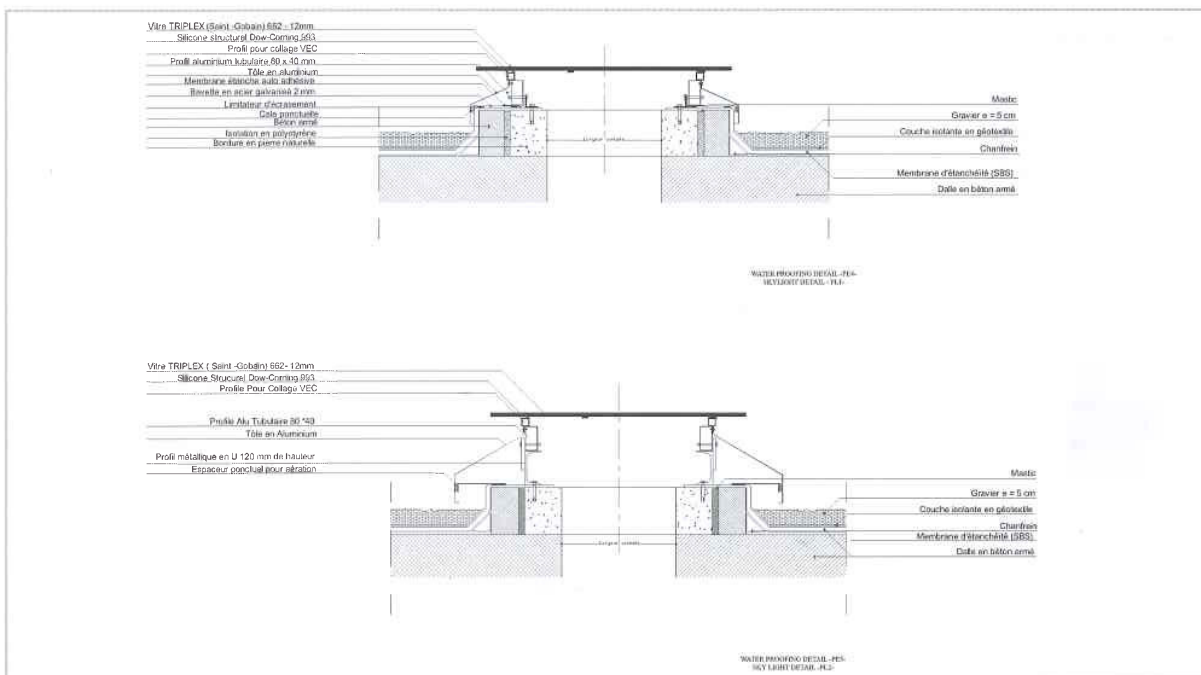
Fig 18- Technical drawing of the sky-lights (Fischfisch/Daoud).

Concerning the blocked-up sky-lights of the first-floor corridor a modern technique has been used that will minimize the problem of maintenance (**Fig. 18**).

The same has been applied to the sky-lights of the *sūq*'s large courtyard. All kinds of unsuitable covers (sheet metal, cement, wood, etc.) were removed from the openings and recovered with panels of laminated glass on an aluminium support in order to protect the interiors from rain-water and at the same time assure the necessary ventilation and lighting.
