## The Restoration on Sūq Ḥarāj

(Antoine Fischfisch  
and Michel Daoud)

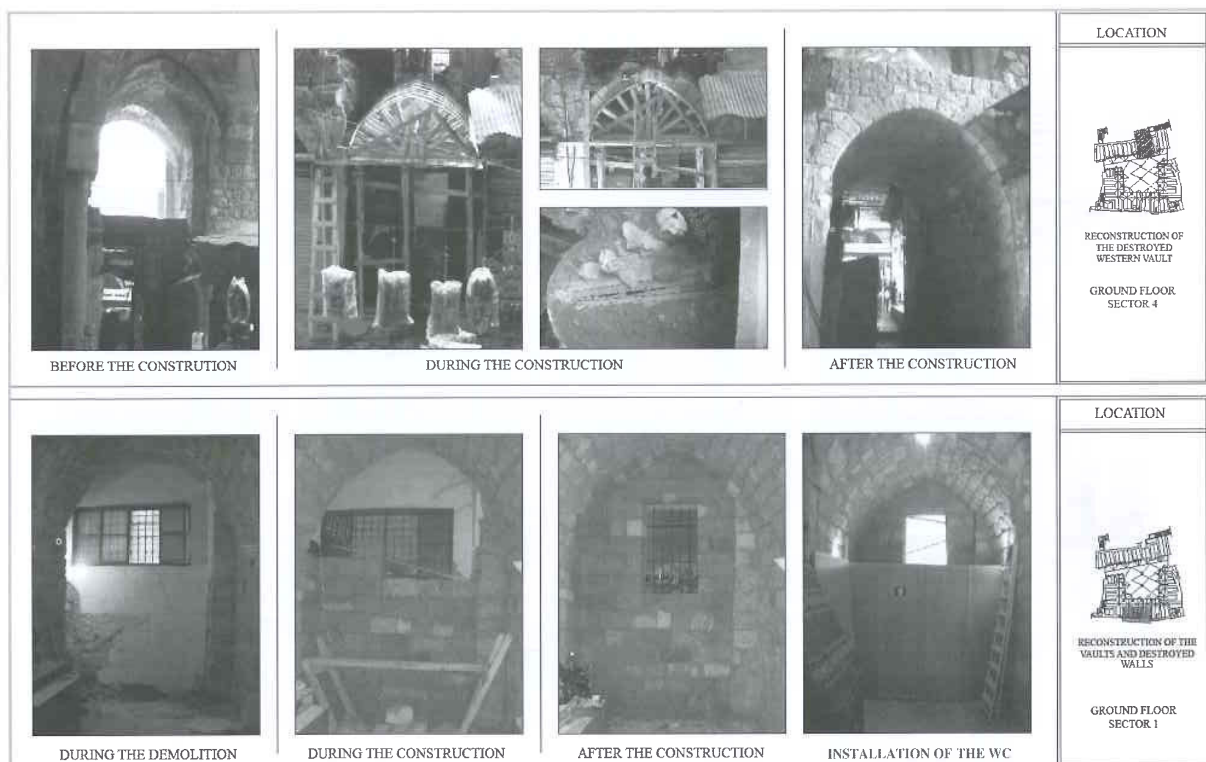
Fig. 6- Western passage and an eastern shop-box during reconstruction (Fischfisch/Daoud 2003-04).

The documentation comprises all steps of an intervention, namely the initial state before the restoration, the operation as such and the final result (Fig. 6).

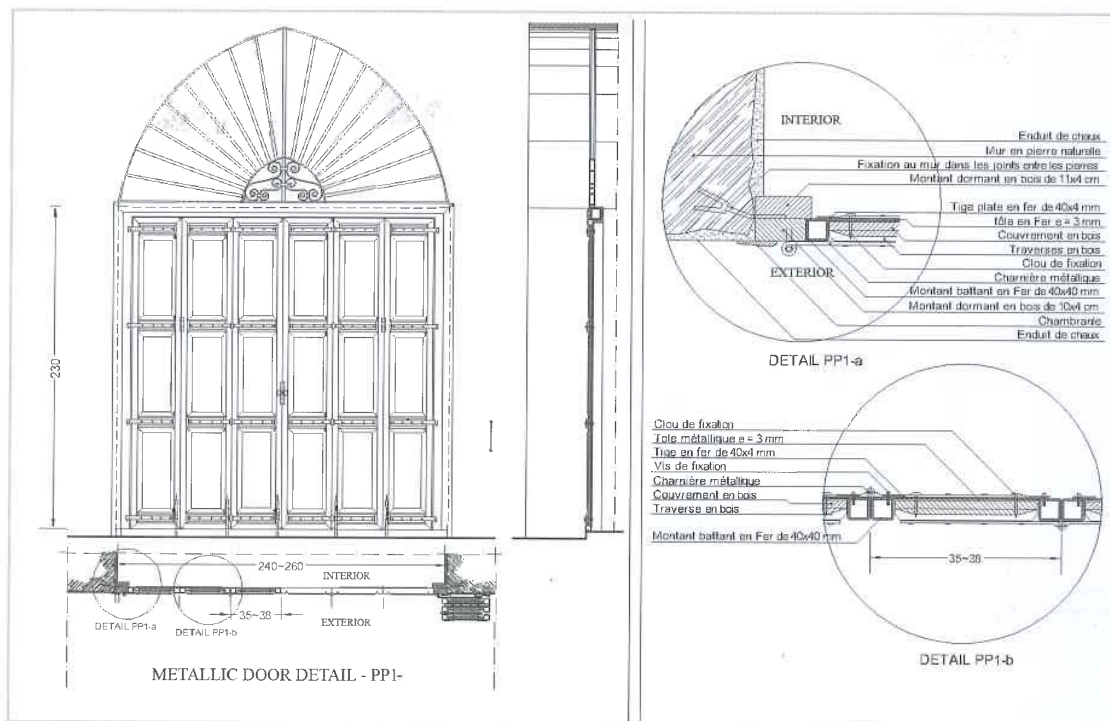
Fig. 17a- Technical drawing of the new shop shutters (Fischfisch/Daoud).

For the sake of security the inhabitants of the *sūq* have replaced their old wooden doors/shop frontage shutters with new metallic ones; only few wooden shop shutters go back to the times of the French Mandate (around 1930). In meeting the needs of the *sūq*'s inhabitants we have chosen a modern interpretation for the shop shutters, in harmony with the historical space but without obliterating the aspect and character of the building's architecture: we have installed shop shutters from metal covered on either side with panels of treated wood but with modern frames so that it is obvious that they are not the original shop shutters. In the north-eastern corner of the courtyard we have left in place two of the shutter lintels as a witness to the Mandate period (**Fig. 17: a-b-c-d**).

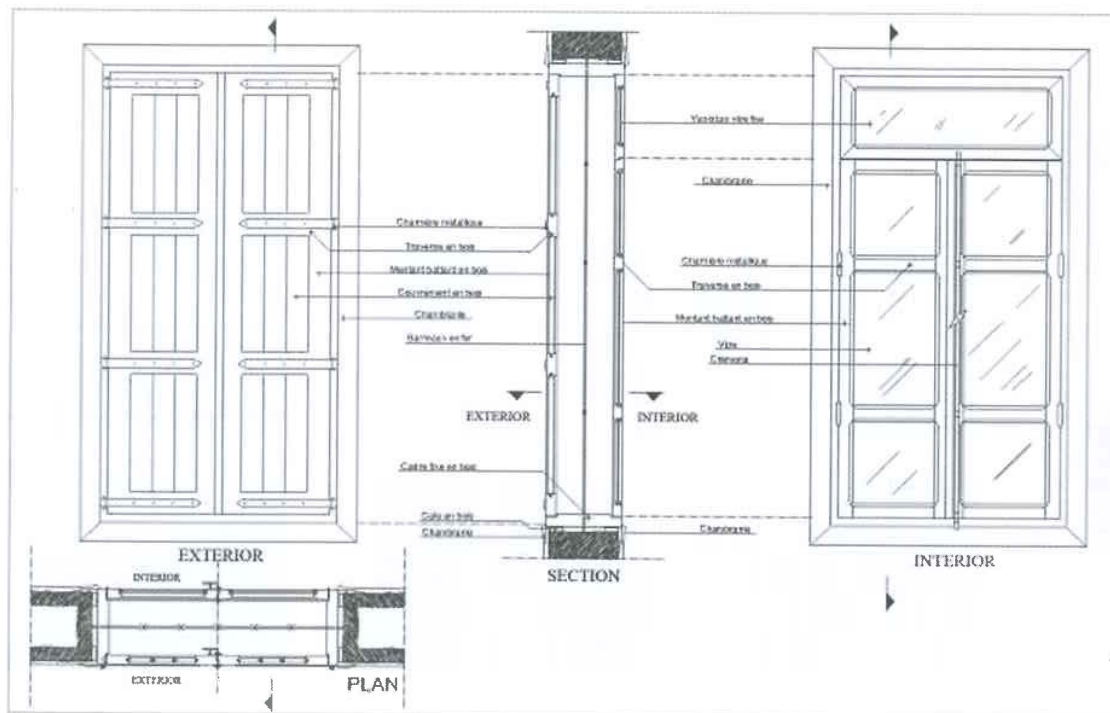
Fig. 17b- Technical drawing of windows and window shutters (Fischfisch/Daoud).
